CASE STUDIES

Foundry: Conveyor Transfer Point Re-Engineered

Material Loss Eliminated, Conveyor Downtime Reduced, \$160K+ Saved Over 5 Years

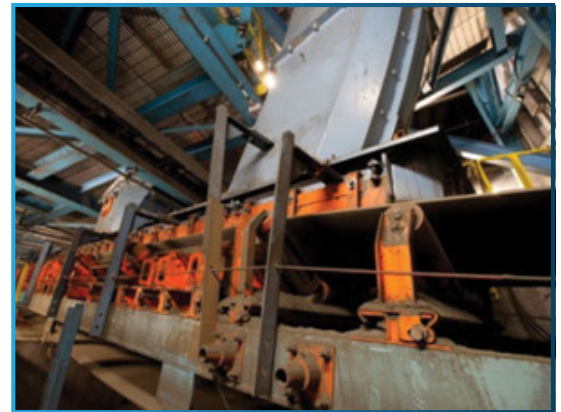
An eastern Pennsylvania foundry was experiencing severe material spillage at a conveyor transfer point due to incorrect transfer-chute design, improper loading, and insufficient clearance. The problem was so severe that the task of cleaning up spillage multiple times each day while trying to keep up with other maintenance duties was significantly increasing maintenance costs and impacting employee morale. Further, when visitors, including prospective clients, toured the plant, they were subjected to dust and falling sand. By applying current best conveyor-practices, understanding human nature, and applying sound engineering practices to transfer point design, AIRMATIC embraced the relationship between safety and morale, production, and profit to solve the problem.

Upon inspection, AIRMATIC Application Specialists quickly discovered the distribution belt was loading the receiving belt too close to its tail-end. This caused belt-vibration and excessive belt-movement along the belt-line. In addition, the existing transfer chute structure was oversized for the receiving belt, causing overloading and material spillage along the length of the conveyor. Finally, without primary

The first step was to remove the existing chute. Then, AIRMATIC extended the tail end of the receiving belt by four feet. Doing so allowed the tail pulley to be pushed back and away from the incoming sand. Furthermore, moving the tail pulley helped stabilize the belt line, which increased belt-life and enabled the installation of a MARTIN® Tail-Box System to prevent material spilling off the tail of the conveyor.

New chute walls installed 3/4-inch above the belt-line, according to CEMA® guidelines, and positioned so as to load material centrally on the belt, allowed the material to take on a symmetrical profile on the receiving conveyor and thereby minimize the potential for tracking problems and spillage. To eliminate belt bounce, AIRMATIC installed a wrapped, chevron-style head-pulley that maintains continuous contact with the belt to not only prevent punctures by deflecting fugitive material away, but also reduce noise by 50 dBA.

An idler conversion kit with support bars eliminated all belt sag and ensured the new MARTIN® ApronSeal™ skirting system would contain material and airborne dust where it is most prone to spillage. Finally, two primary belt-cleaners were installed at the distribution belt's head pulley, effectively eliminating carryback.
