Precast Concrete: Silo Vibrator Installation

Flow issues resolved with the right equipment for the job and proper installation.

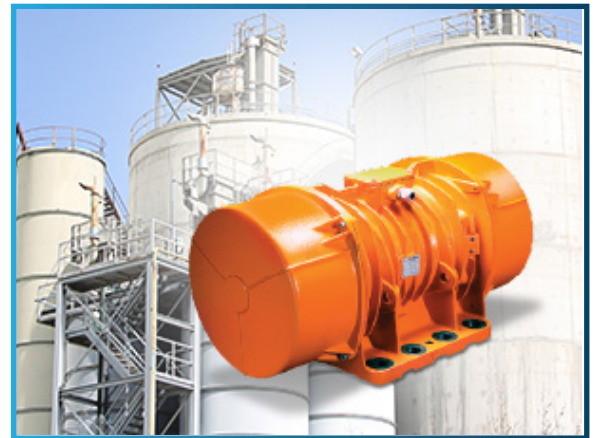
An AIRMATIC Vibration Specialist also noted that the Customer’s existing vibrators were not installed correctly. The mounting position had vibrator shafts perpendicular to the ground. A mistake that makes the vibrator much less effective and shortens its life.

Poor material flow resulting from the old and improperly installed vibrators, caused lengthened batch cycle times and less efficient mixing when producing concrete. The longer batch times and resultant delays in production led to having to idle manpower.

The AIRMATIC Product Manager recommended new, properly sized vibrators on the silos and provided engineering information on how they were to be properly installed. The existing vibrators were removed and replaced with ITALVIBRAS Rotary Electric Vibrators — installed in accordance with AIRMATIC drawings and specifications. The proper installation of the new rotary electric vibrators solved the material flow problem and unsafe practices such as climbing on conveyors, climbing ladders, or riding man lifts to get to the material hang-up were eliminated.

Installation of the new, properly sized vibrators mounted in the correct orientation improved material flow and decreased the length of concrete batch cycle time. This led to improved employee efficiency and fewer delays in completing customer orders. In addition, employees are no longer damaging the silo in a brute-force effort to improve material flow. The customer was delighted to finally have his material flow problems resolved.
