Foundry: Automatic Lubrication System Installation

Automating critical maintenance saves man-hours, reduces risk, and increases equipment uptime.

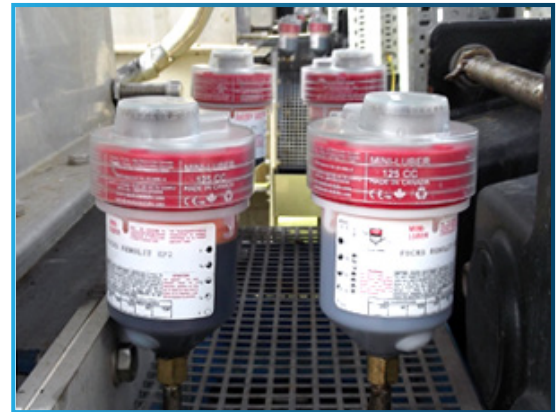
An AIRMATIC Industry Specialist working with the foundry knew exactly what to recommend: A high-performing, point-of-use automatic grease lubricator. Specifically, the Titan II CL Cartridge Luber from ATS Electro-Lube. The reason this is the perfect solution is that the Titan II is a self-contained, microprocessor-controlled, motor-driven automatic lubricator. This device dispenses lubricant at pressures up to 900 PSI, enabling it to service single-point applications up to 30' away or multi-point applications up to 20' away. The grease output is not affected by temperature or altitude, so it can operate atop the sand silo without interference from harsh conditions and temperature fluctuations. AIRMATIC

suggested the foundry also pair the new lubricator with a four-point distribution block, giving the maintenance team the ability to grease both bearings with one unit. The new setup allowed the foundry to trade in the cumbersome daily maintenance routine for a simple, bi-weekly check-up of the bearings.
